# 2016 DIRT Report

## Version 10.0

The Damage Information Reporting Tool (DIRT) is the result of the efforts made by the ORCGA to gather meaningful data about the occurrence of facility events. An “event” is defined by the DIRT User’s Guide as “the occurrence of downtime, damages, and near misses.” Gathering information about these types of events give the ORCGA the opportunity to analyze the contributing factors and recurring trends. This allows the ORCGA to identify potential educational opportunities to meet our overall goals of reducing damages and increasing safety for all stakeholders.

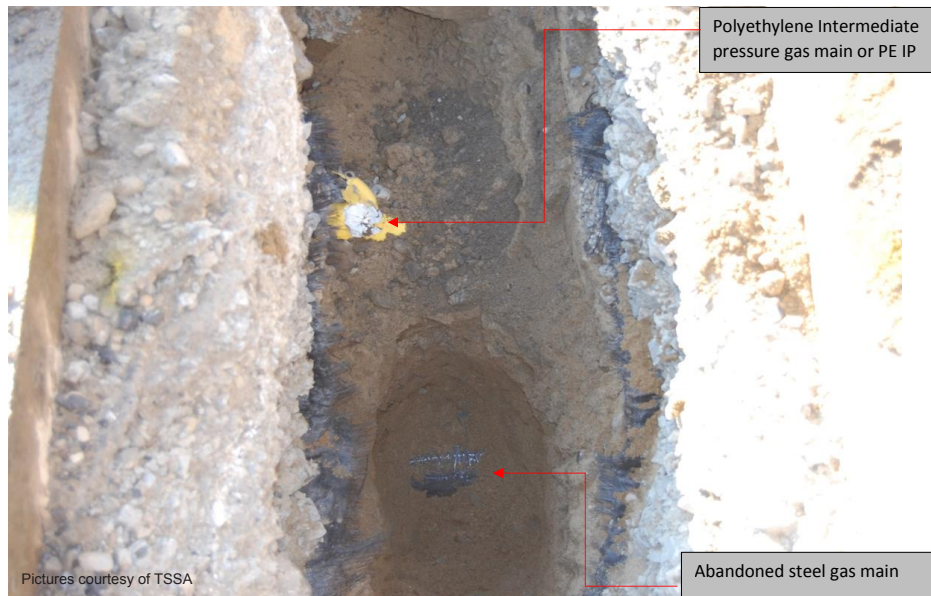
The locate sheet had identified that the gas main marked was composed of polyethylene plastic. The locate sheet stated: 3" PE IP (polyethylene Intermediate pressure). What the contractor actually day-lighted was an old abandoned 4 inch steel gas main. The steel main looked brand new despite the fact that it was abandoned 25 years ago.

Granted, 4 inch and 3 inch look alike, but plastic and steel cannot be confused. The contractor simply did not notice or know what PE IP is an acronym for polyethylene plastic and intermediate pressure.

If the contractor did not know what PEIP meant, he or she should have made a quick call to the distributor's local damage prevention representative for assistance. The representative would have explained the difference and the contractor would have kept looking and found the PEIP main immediately next to the old, abandoned steel main.
